Property Inspection Report

David Donnelly
GreenLight Home Inspection Services

123 Min Street
Inspection Prepared For: Sample Johnny
Agent:

Date of Inspection: 5/5/2023
Year Built: 3 Size: 1400
Weather: Sunny 12C

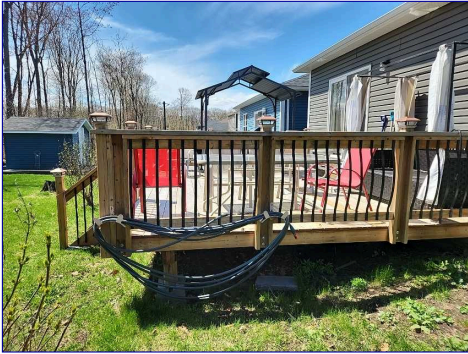
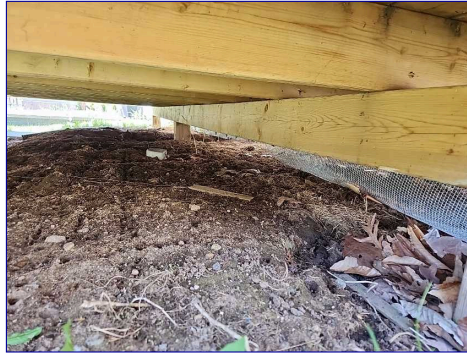
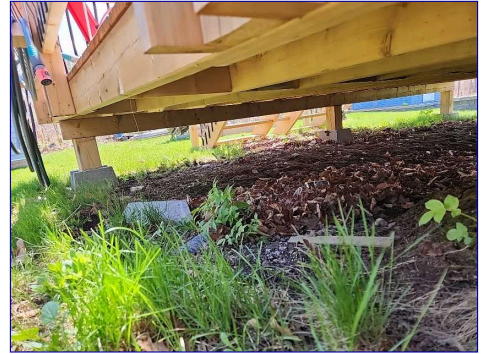
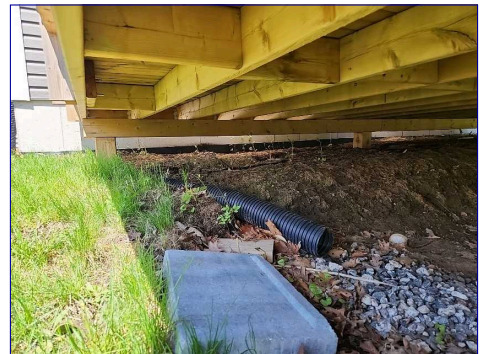
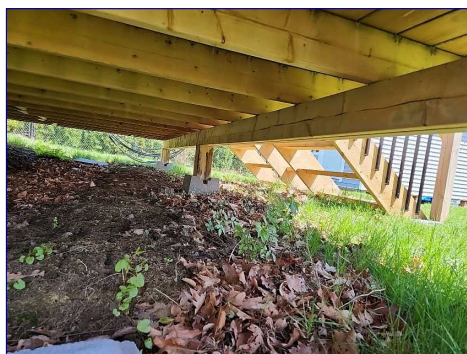
6. Deck/Balcony

- The wood in the deck needs painting or treating. Recommend painting or treating wood on the deck to help protect it from damage.

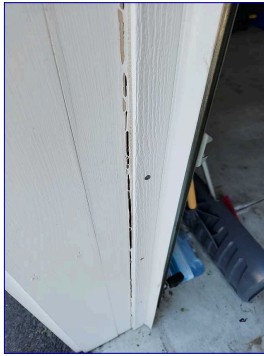
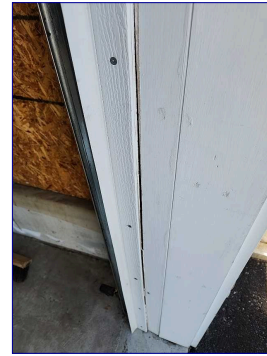
8. Caulking

Condition:
• Caulking needed

• The caulking is dried and cracked at trim around garage door. Recommend a professional contractor to repair the caulking.

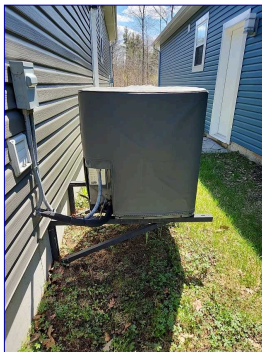
1. Exterior A/C - Heat Pump 1

- Location: West
- Approximate Age: 5-10+ years
- ---not tested due to exterior temperatures for the last 24hrs
- Insulation: Yes
- Improper clearance (air flow): No

- The air conditioner was not operated due to the outside temperature. The unit should not be operated when the outside temperature is less than 60 degrees. Recommend a licensed HVAC contractor clean and check the **a/c** performance before using.

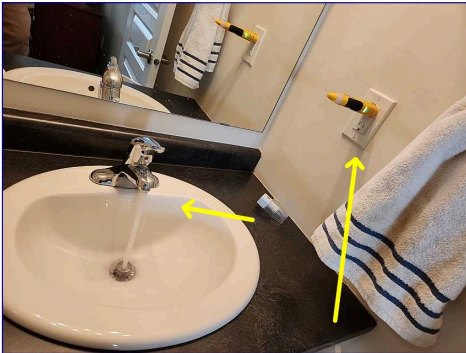
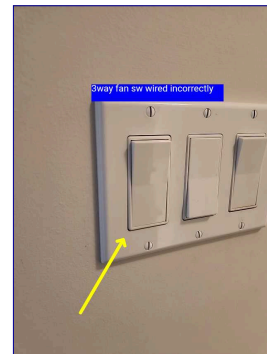
- Ground-fault outlet was not operating properly in bathroom 1. Recommend a licensed electrician to replace.

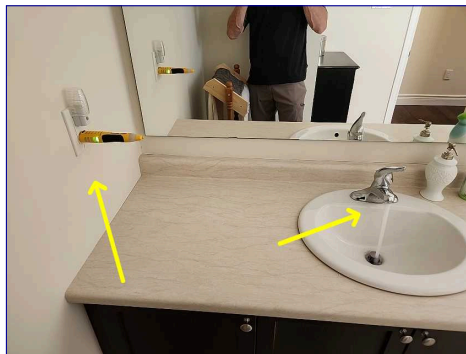
- Present: Yes
- Operable: Yes
- GFCI present: Yes
- GFCI operable: NNo
- Recommend GFCI

- Ground-fault outlet was not operating properly in bathroom 2. Recommend a licensed electrician to replace.

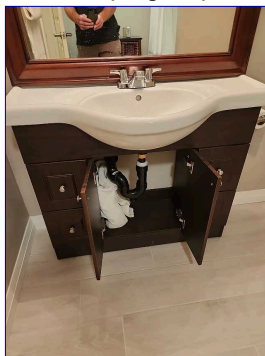
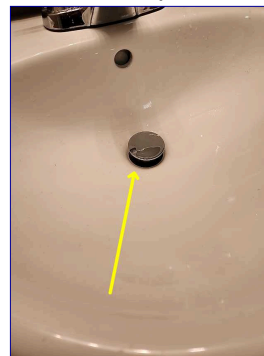
- Faucet leaks: No
 - Pipes leak: No
- Observations:
• The sink drain plug requires adjustment in bathroom 3. Recommend a licensed plumber repair or replace.

Drain stopper not functioning properly

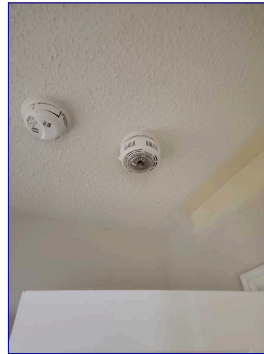
- At least one smoke alarm was inoperable, which is a safety concern. Recommend repairing or replacing the alarm(s) as needed.

Recommend service and repair to Main floor (hallway not strobing) and basement systems not responding to tests.

Hallway detector not flashing during test - recommend evaluation and repair.

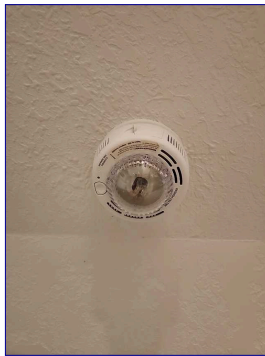
Basement smoke detectors did not respond during a test. - Evaluation and repair required.

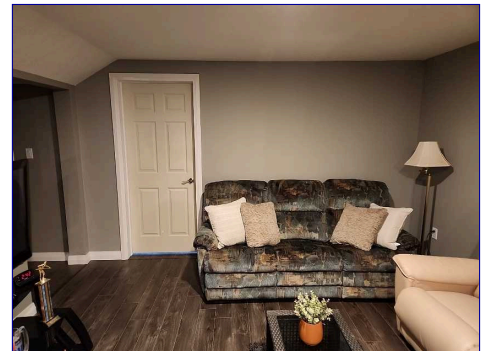
1. Foundation

- The Basement View limited visibility due to finished construction
- Foundation walls were covered with paneling/drywall/insulation/storage and were not visible. It is always possible that hidden damage may exist in non-visible areas. Consult a licensed contractor as needed.
- Foundation walls were covered with storage material and were not visible. It is always possible that hidden damage may exist in non-visible areas. Consult a licensed contractor as needed.

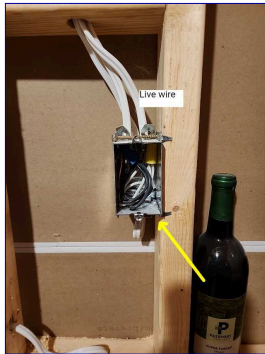
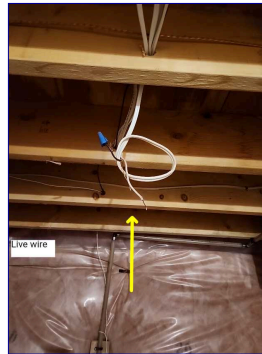
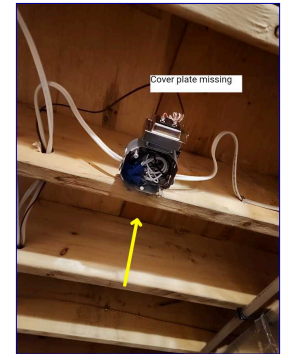
- At least one cover plate is missing at a receptacle in the basement, which is a safety concern. Recommend installing cover plates.
- There is a live wire not correctly terminated in the basement., which is a safety hazard. Recommend a licensed electrician repair.
